Technical Preservation Services  
Preservation Assistance Division  
National Park Service  
U.S. Department of the Interior  
Washington, D.C.

# Interpreting the Secretary of the Interior's Standards for Rehabilitation

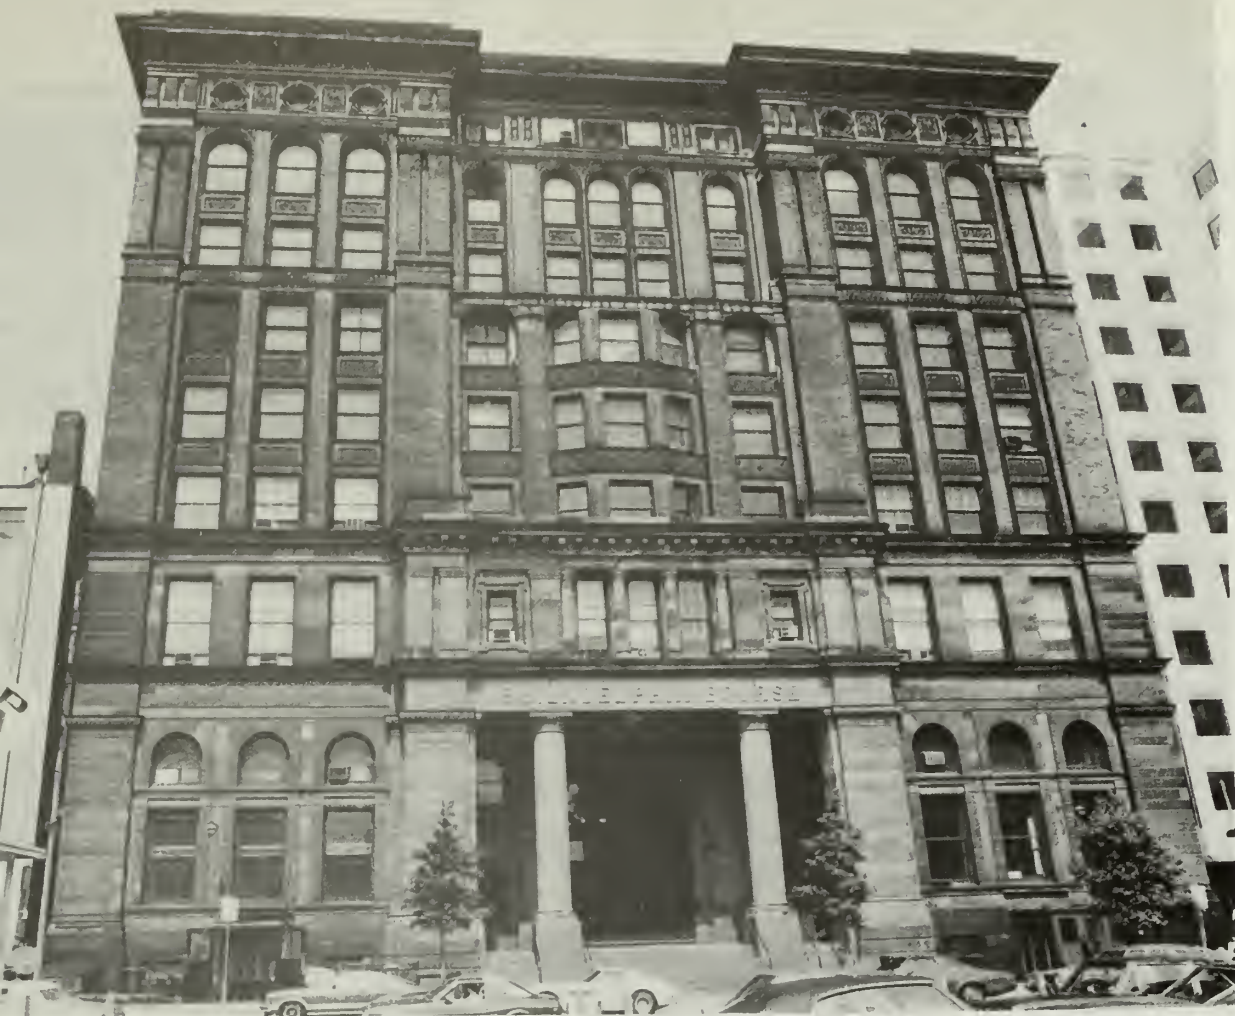
1. East elevation showing wooden vestibules flanking main entrance, added c. 1920.

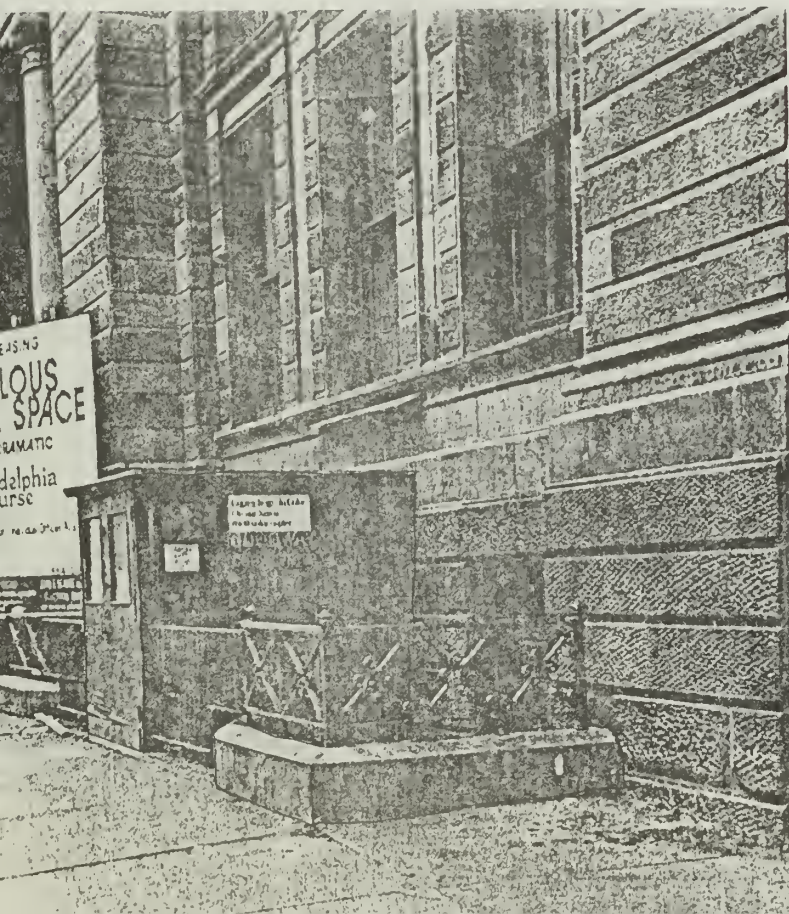
2. Deteriorated condition of vestibule.

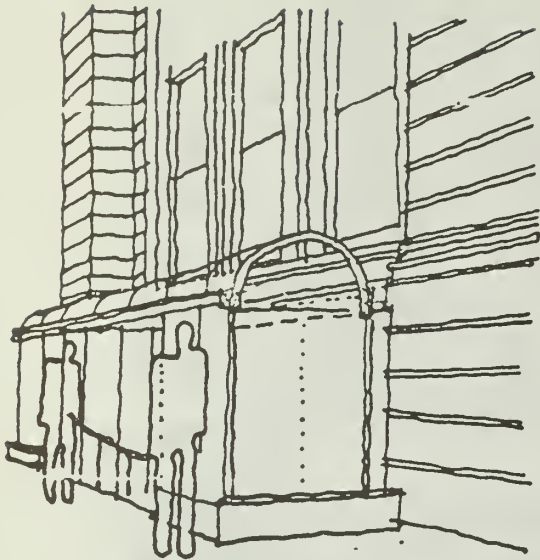
3. Initial canopy design was not approved by NPS because its height obscured the first floor windows.

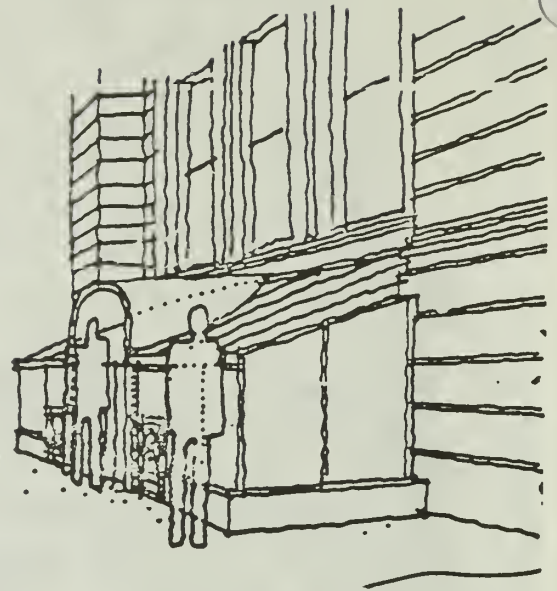
4. Revised canopy design met the NPS height condition but introduced potential pedestrian safety problems.

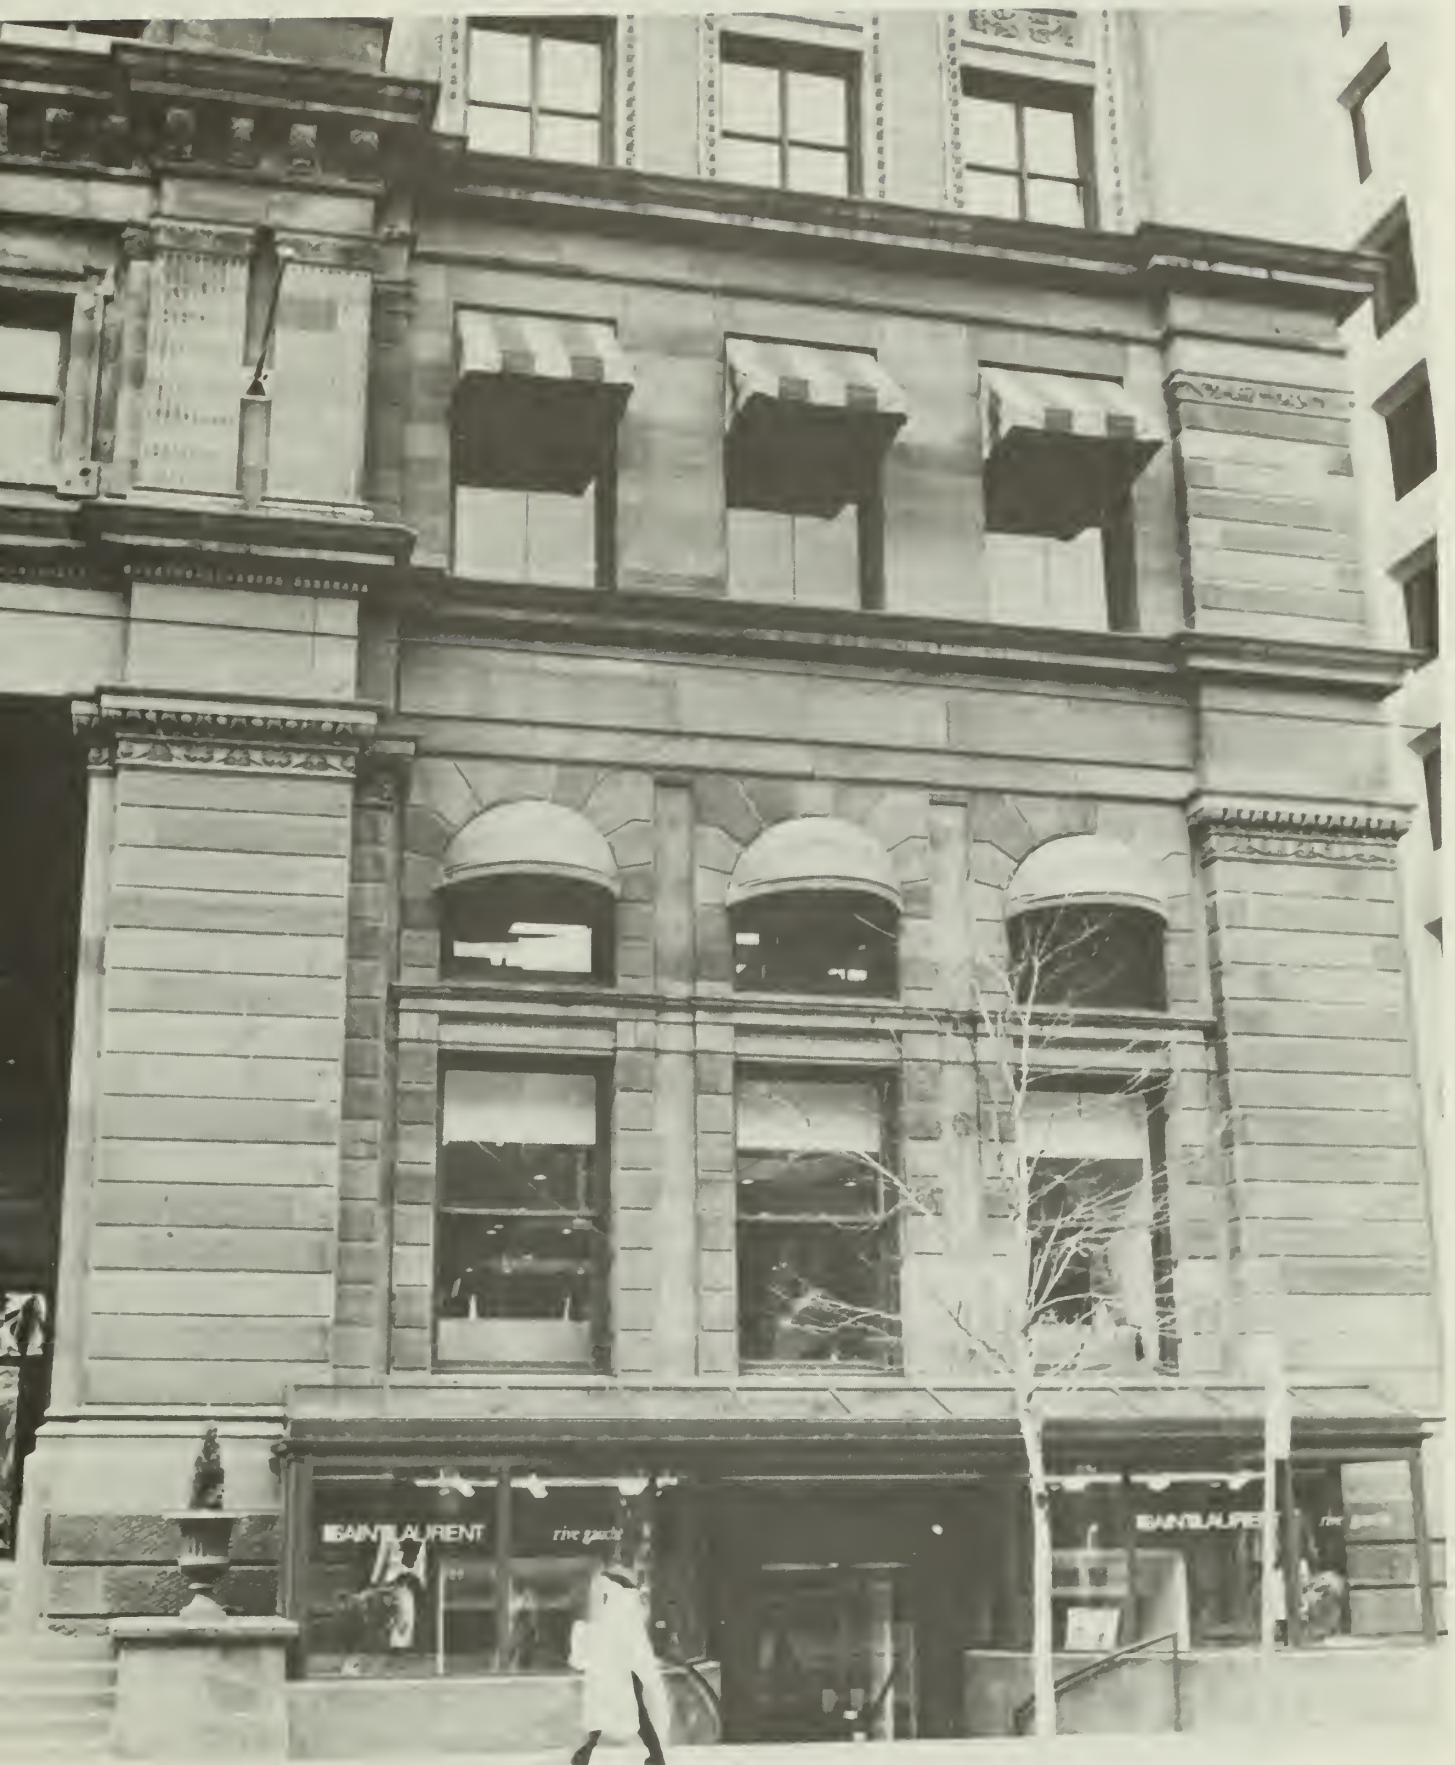
6. The Option A entrance canopy in place.

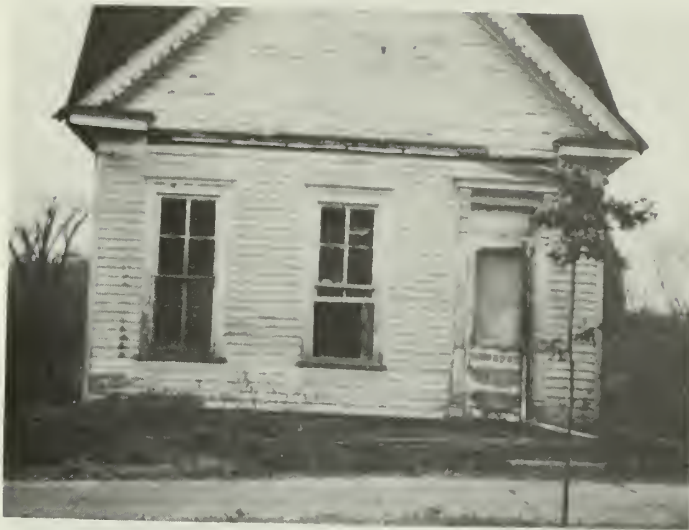
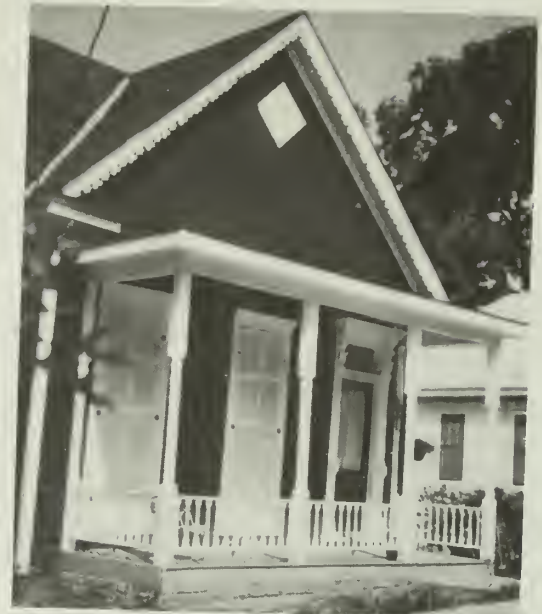
4. The 1880s cottage was in deteriorated condition prior to rehabilitation. Ghost marks of missing porch are evident. The original 2 over 2 windows had survived on the front and were to be repaired according to the plans submitted to NPS for prior review.

5. In the course of rehabilitation the owner elected to remove the original windows and install new ones in a historic design which extended to the first floor. Full-length blinds were also added.

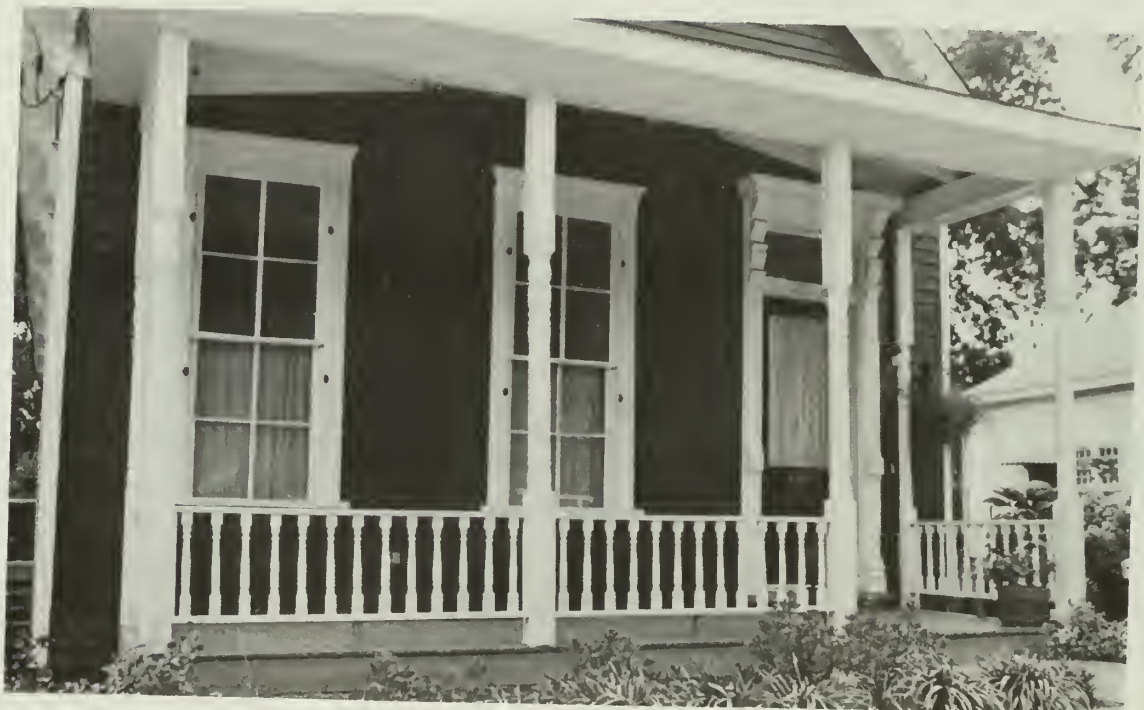
6. After the work was determined not to meet the Standards because of the window alterations, the owner proceeded to reinstall the original ones and thus obtained certification.

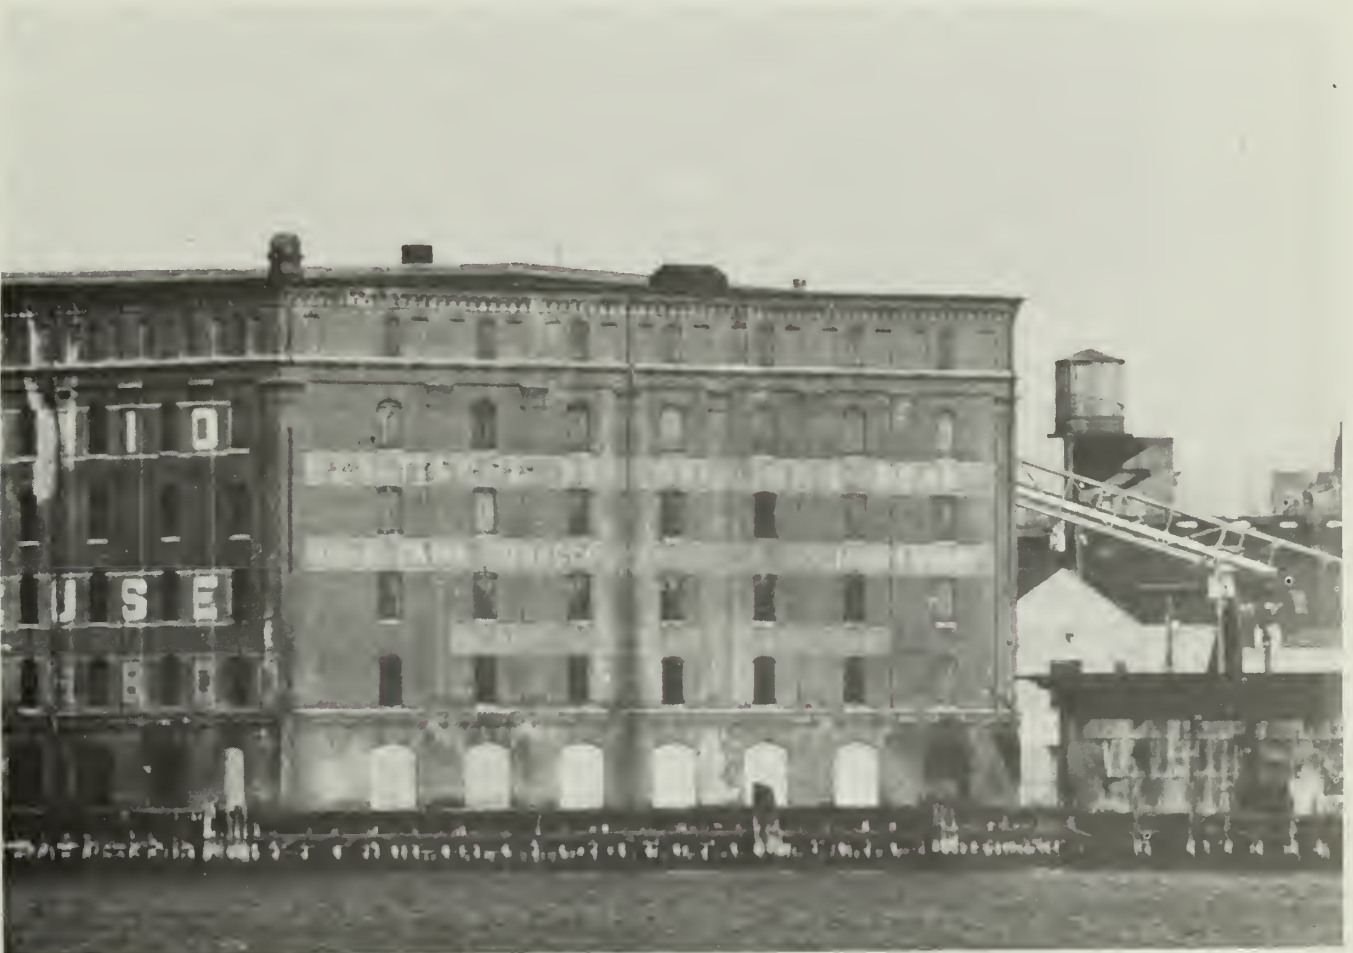
1. The existing south elevation of the 1890s warehouse building with its alternating bands of pilasters and window openings. The size of the openings decreases as the building progresses from the base to the top floor. The brickwork was quite sophisticated for a warehouse structure.

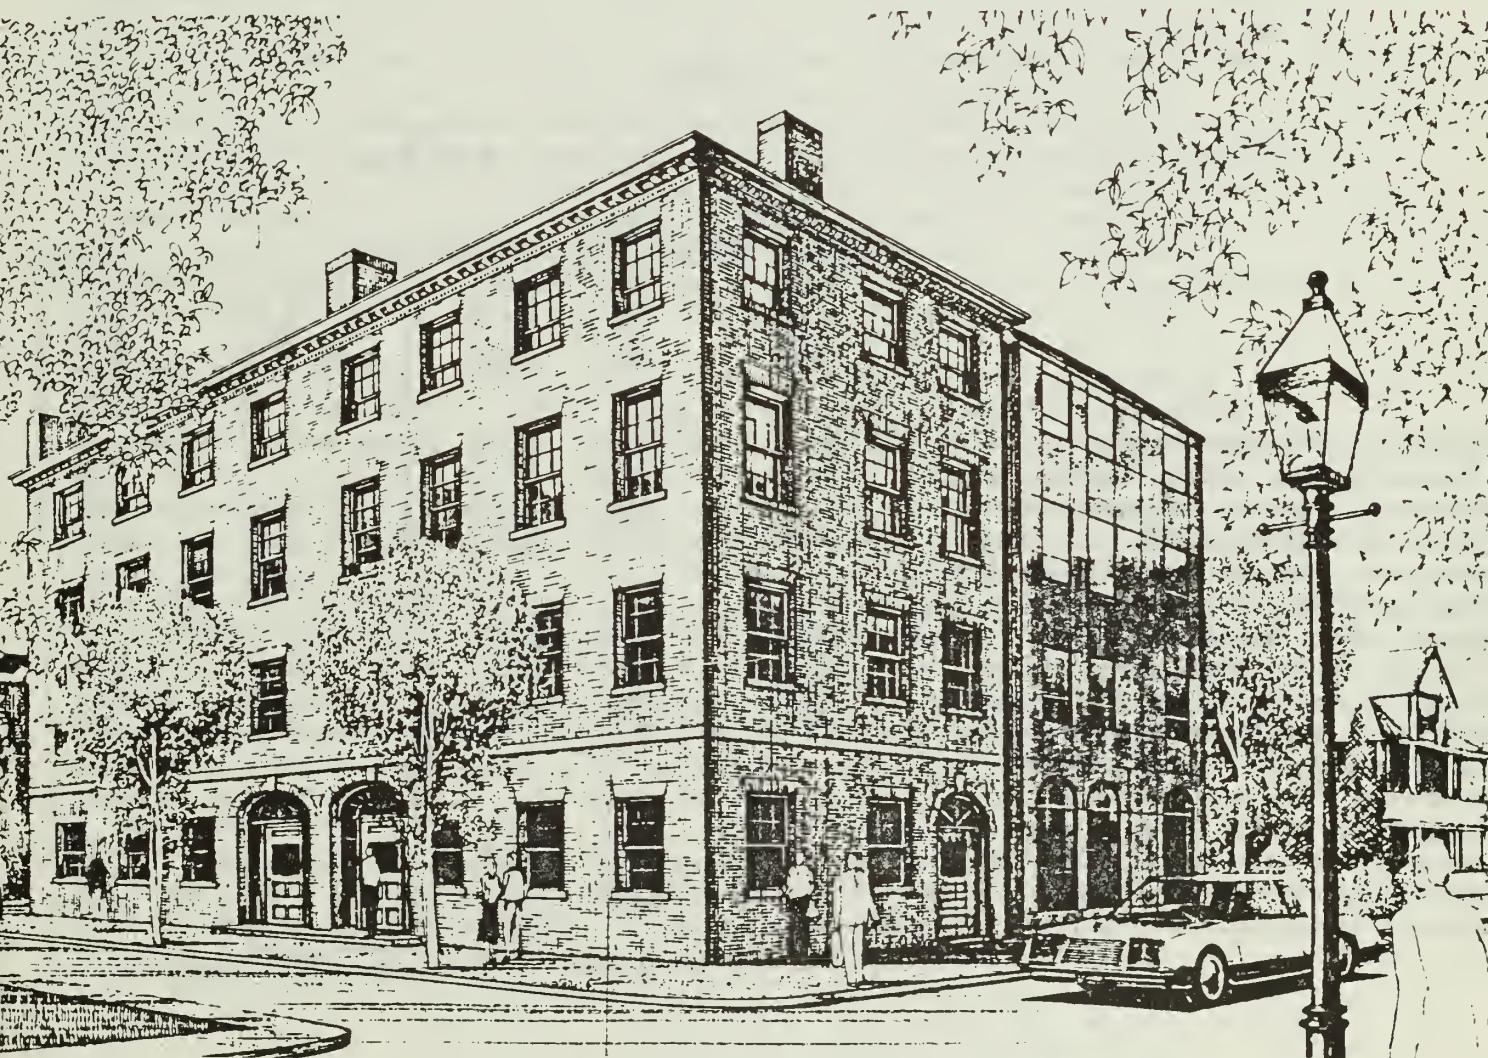
Illustration #2. PERSPECTIVE VIEW. The revised design treated the rear addition as a modern pavilion to clearly differentiate it from the historic structure.

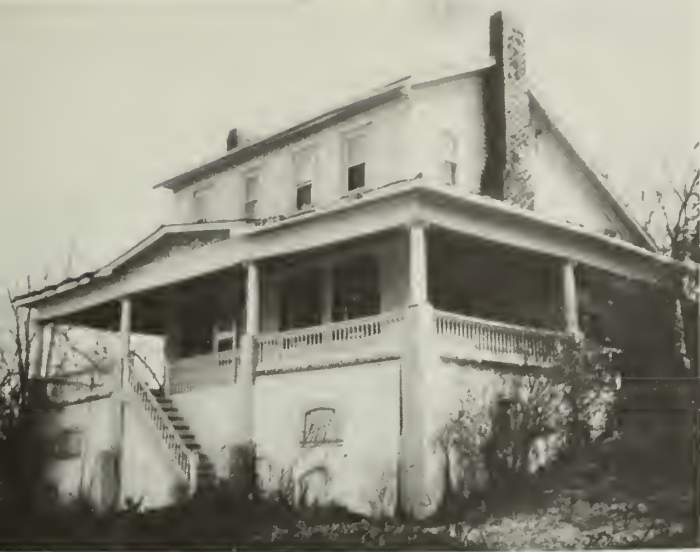
5. The 1830 structure with its large 1910 wrap-around porch characterized by columns resting on brick piers, highly decorative central pediment and turned balusters. The porch was in a deteriorated, but still usable, condition prior to rehabilitation work.

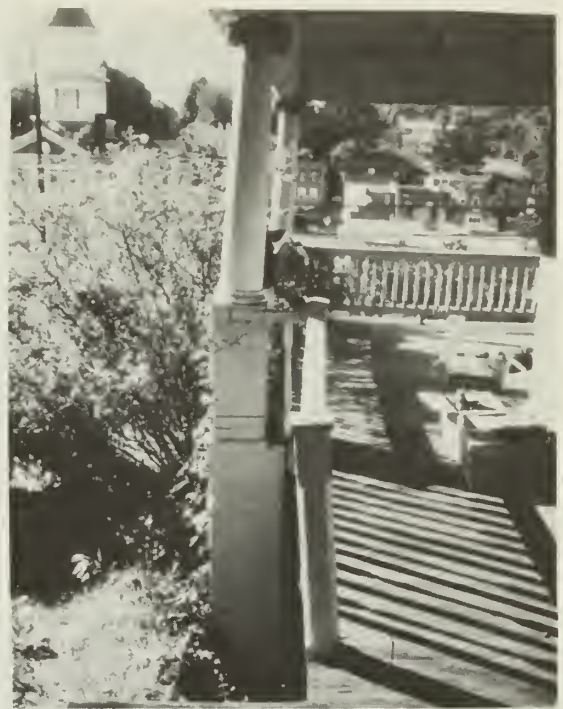
6. A detail of the 1910 porch shows structural problems that need to be corrected. The owner assessed the 1910 front porch as unrepairable, which led to its removal.

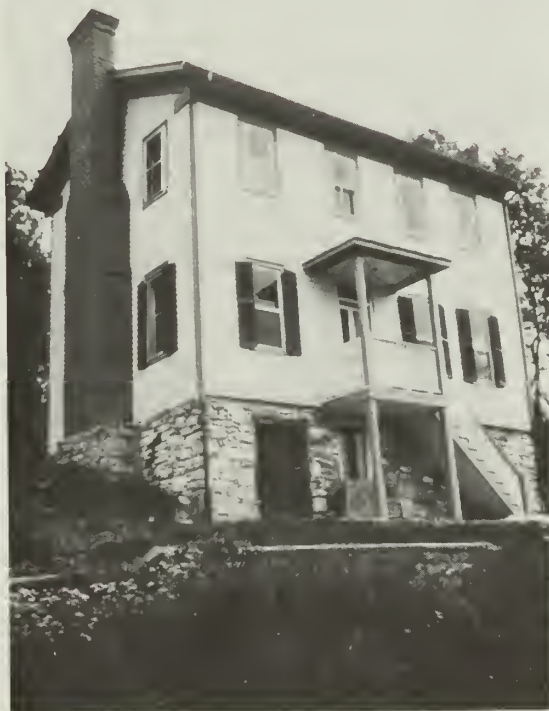
7. The replacement front porch--conjectural in design--was constructed after demolition of the historic porch. NPS concluded that because the 1910 porch was an important character-defining feature and was repairable, it should have been retained. The project was denied certification of rehabilitation for tax benefits.

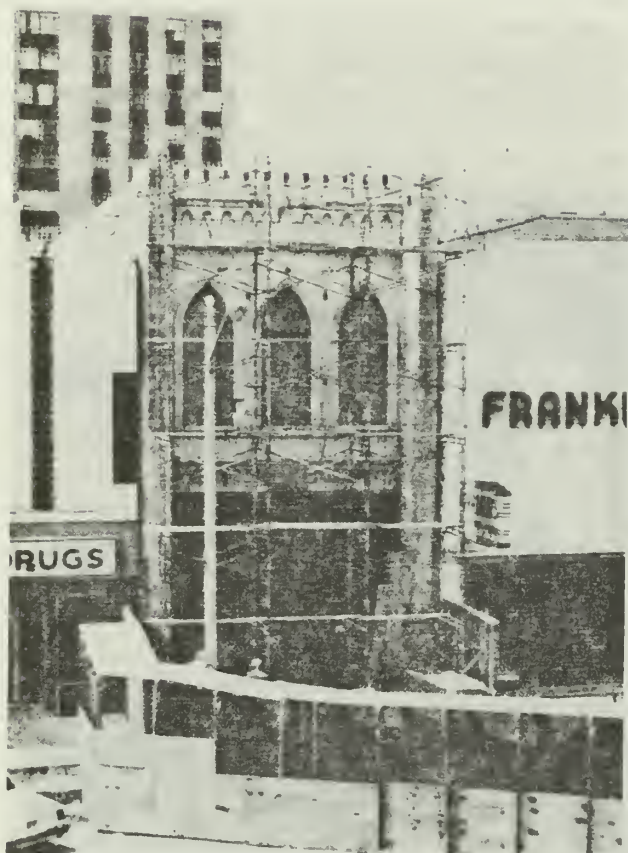
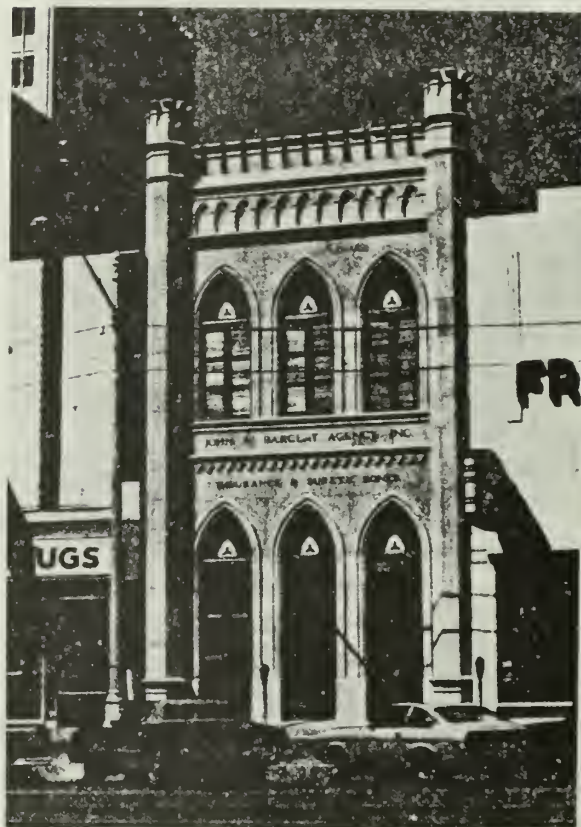
3. When the 1967 storefront was removed, the owner assessed overall damages to the upper and lower levels and felt total replacement of the limestone facade was necessary to restore the historic appearance.

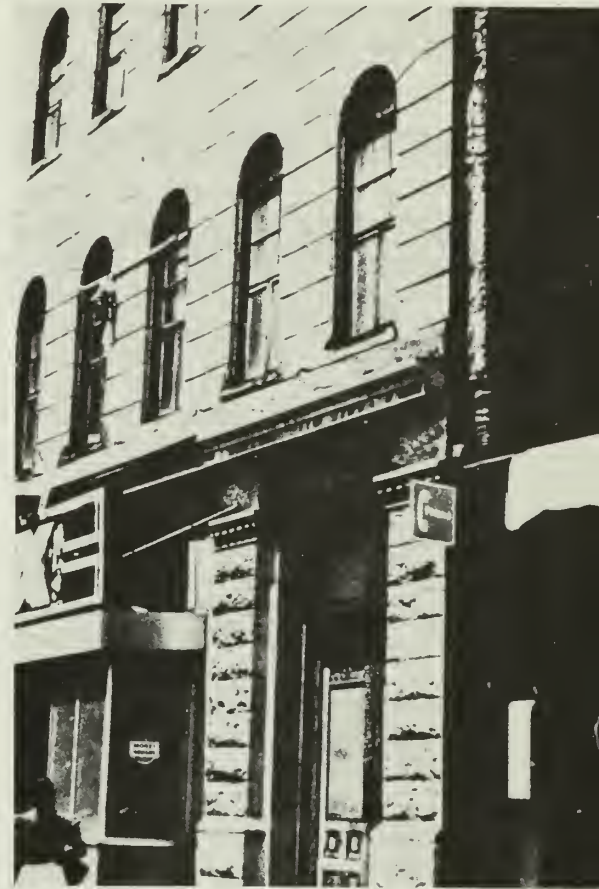
2. The brownstone of the south wall was not as deteriorated and could be retained in place and structurally strengthened by stainless steel pins tying cementitious patches to the sound stone beneath. Limiting the patching to the beveled edges of the stone blocks where the greatest amount of deterioration had occurred was considered a sensitive preservation solution because it left the historic material both intact and visible.

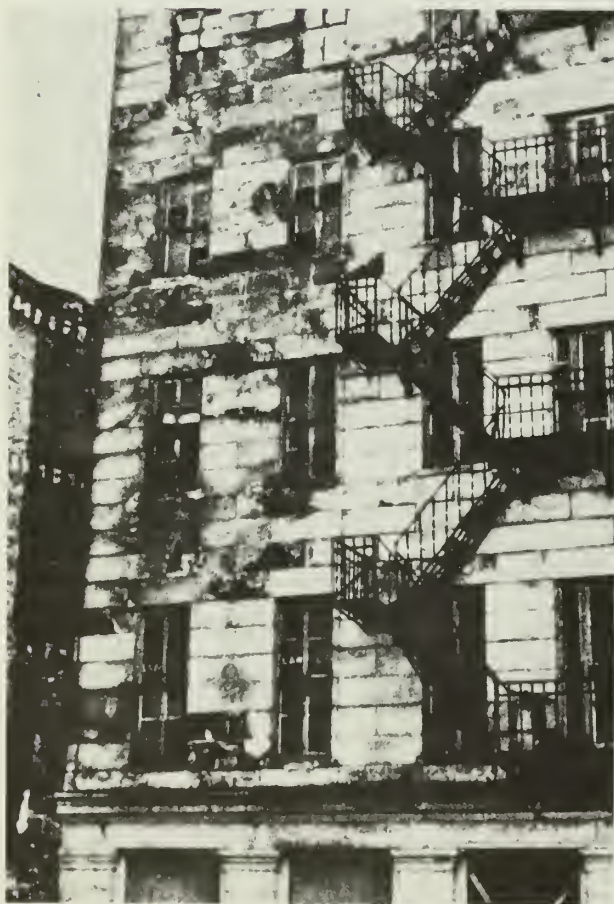
3. Badly spalling brownstone on the north, and less visible, wall was for the most part unsalvageable. Replacement walls were constructed from the second story up, a solution that assured maximum retention of historic material while making the building structurally sound for the new use.

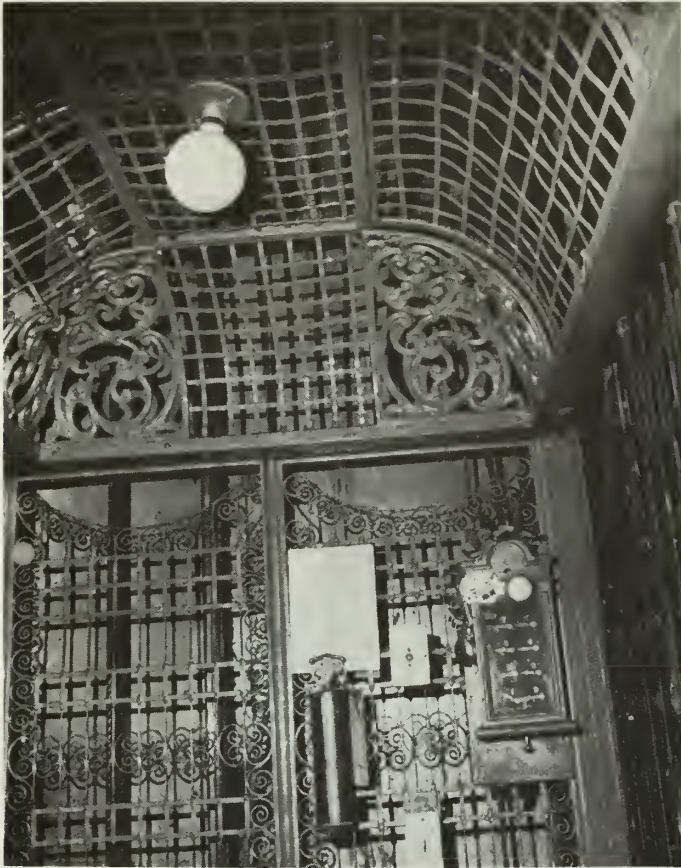
2. This shows a detail of the open dome, manually-operated elevator with its highly decorative iron grill work. Because an enclosed cab was required by State law, the historic elevator was found to be in violation of ANSI building code standards. The consulting engineer thus recommended its removal and replacement with a modern elevator.

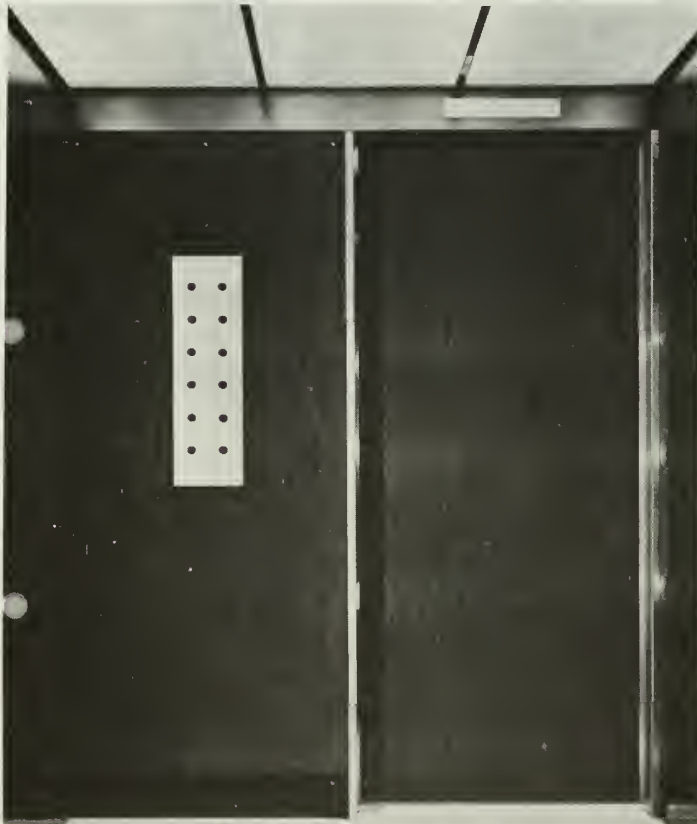
3. The replacement cab featured an enclosed cab and hollow metal shaft doors, in accordance with health and safety codes. Removal of the 1916 elevator eventually led to project denial because the historic elevator was deemed a significant interior feature and, thus, its retention and preservation were necessary to meet minimum preservation requirements.

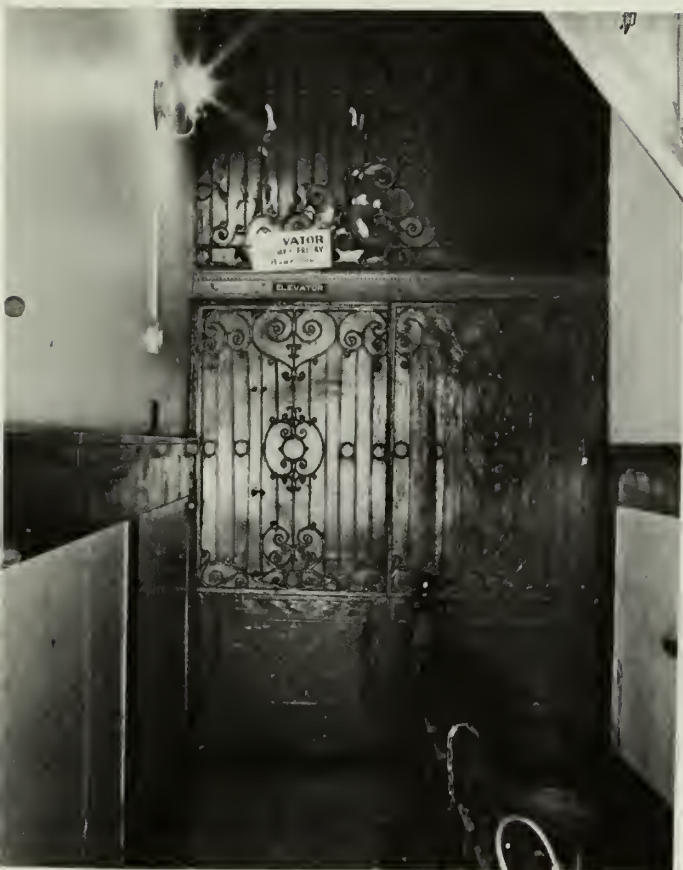
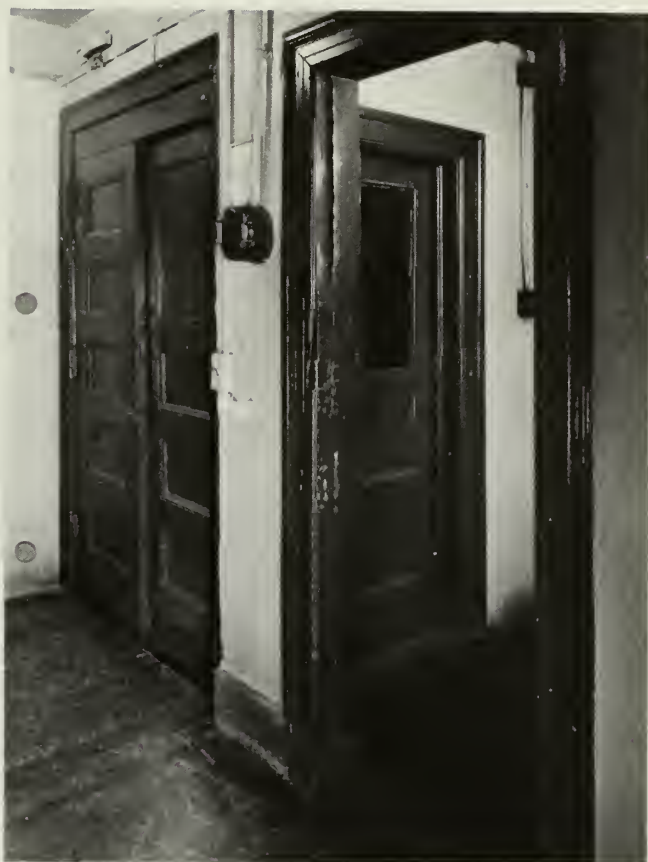
4 and 5. The decoratively detailed elevator doors in the lobby (left) were to be removed as part of the code-required elevator replacement as well as the simpler, panelled doors on floors 3-7 on the west side (right).

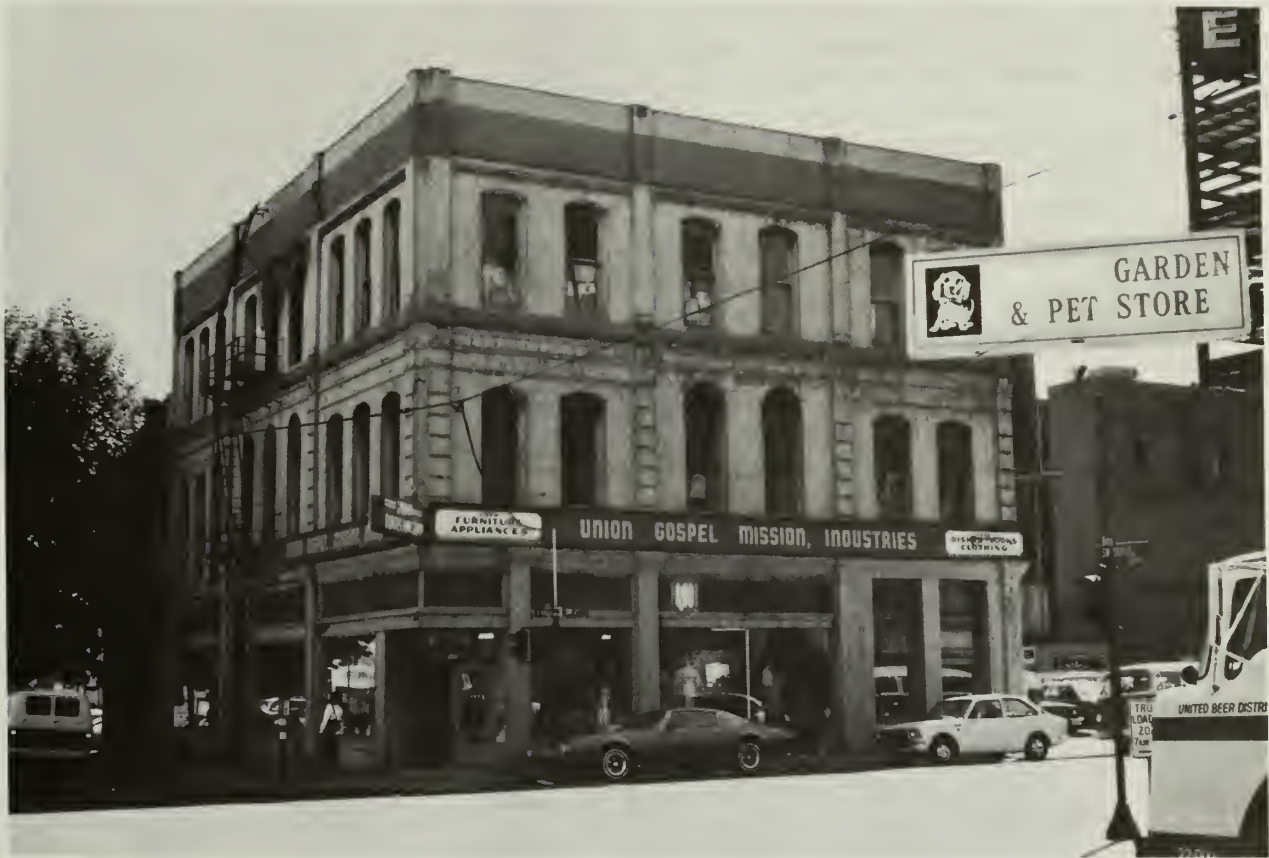
1. The building prior to rehabilitation was a three-story structure prominently located on a corner site in a National Register district noted for late 19th century commercial structures. Originally built in 1884 as a two-story brick building, a third floor was added in 1890, the building was stuccoed and an elaborate projecting cornice was applied. The cornice was lost in the mid-twentieth century and the building suffered a serious fire on the third floor prior to the rehabilitation.

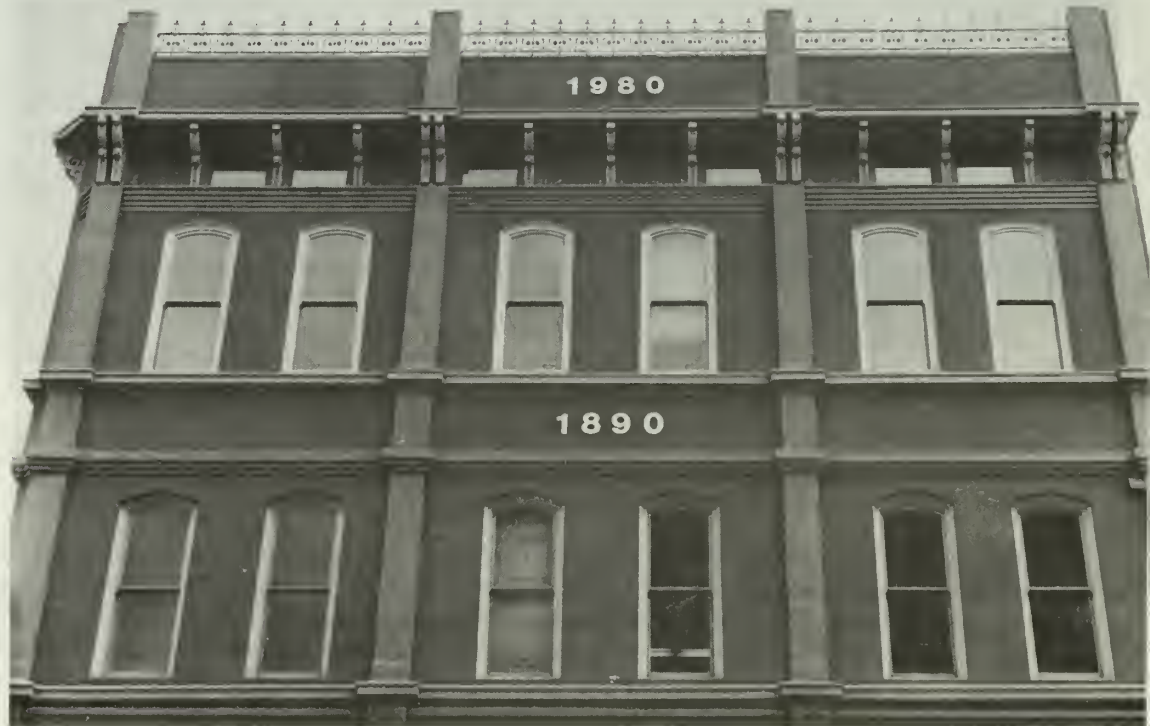
3. The new rooftop addition is not differentiated from the historic resource except by the use of applied dates. The addition is flush with the exterior walls and has adopted historicized features including wrought iron cresting, bracketed cornice, jack-arch windows, pilasters and beltcourses. In this case, however, the addition so altered the scale and massing of the building, that even if the addition had been contemporary in design, it could not have been certified.

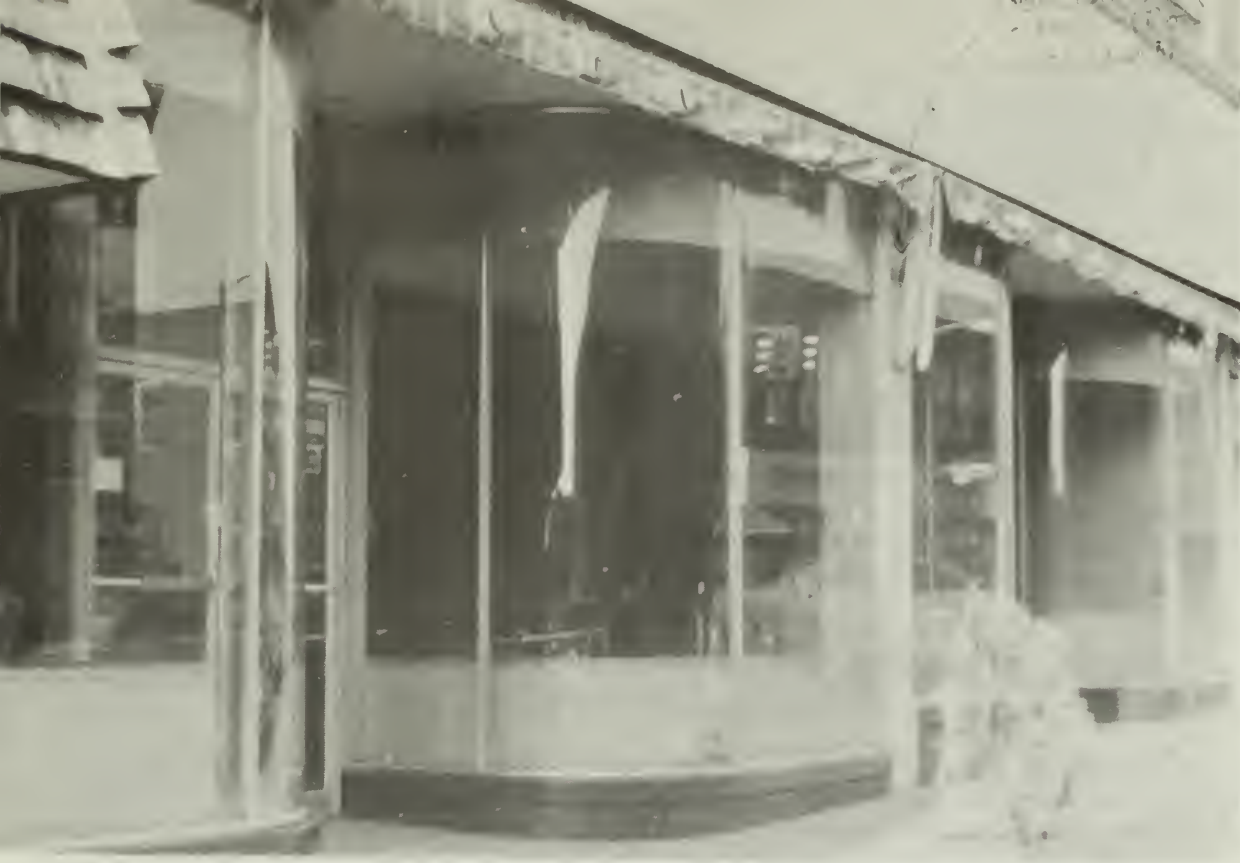
3. The entire storefront was replaced following breakage, during rehabilitation of one of the curved sheets of glass. Expediency and difficulty in locating a manufacturers of curved glass were cited by the owner as reasons for the change.

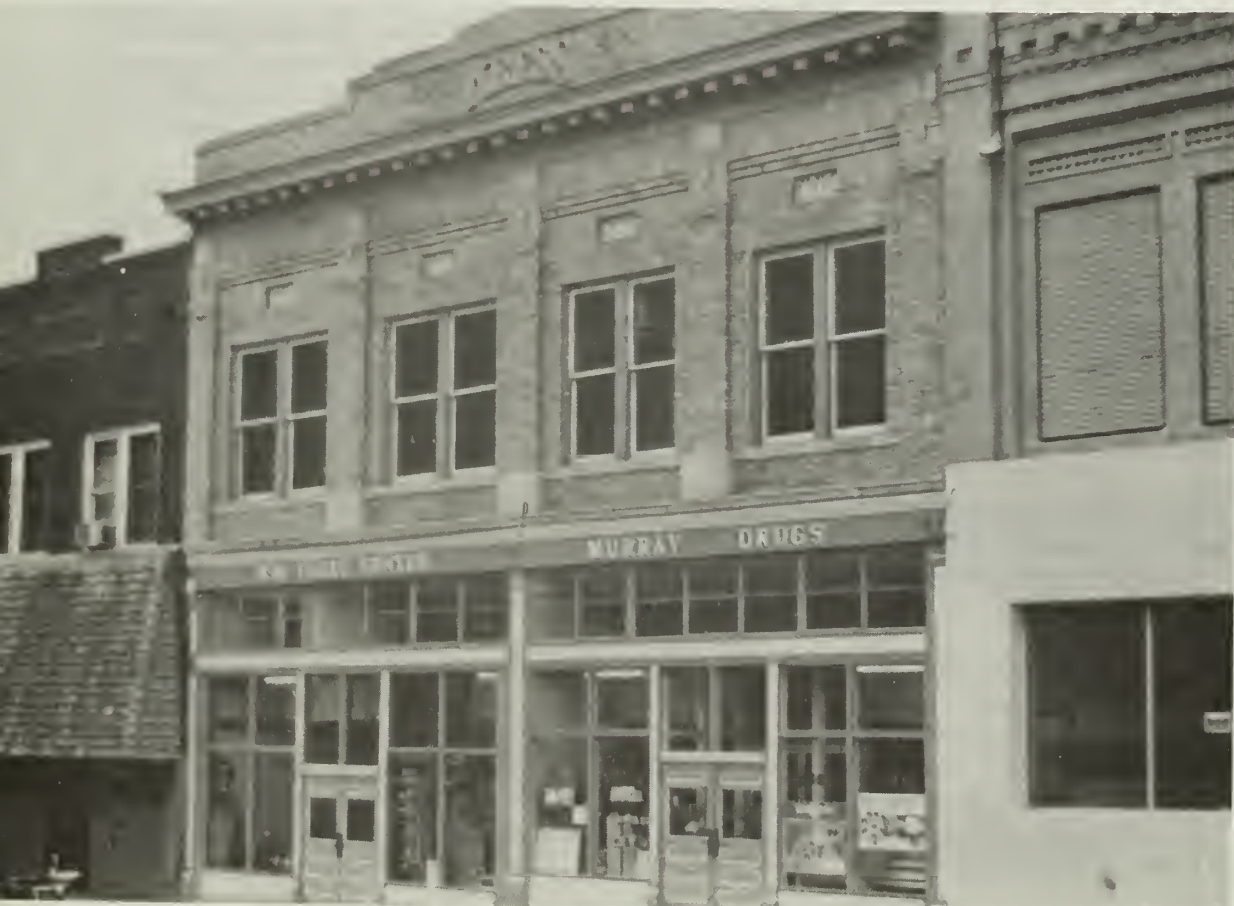
4. View of storefront after rehabilitation showing conjectural appearance of the original storefront — note inappropriate detailing of the transoms and small size of the doors.

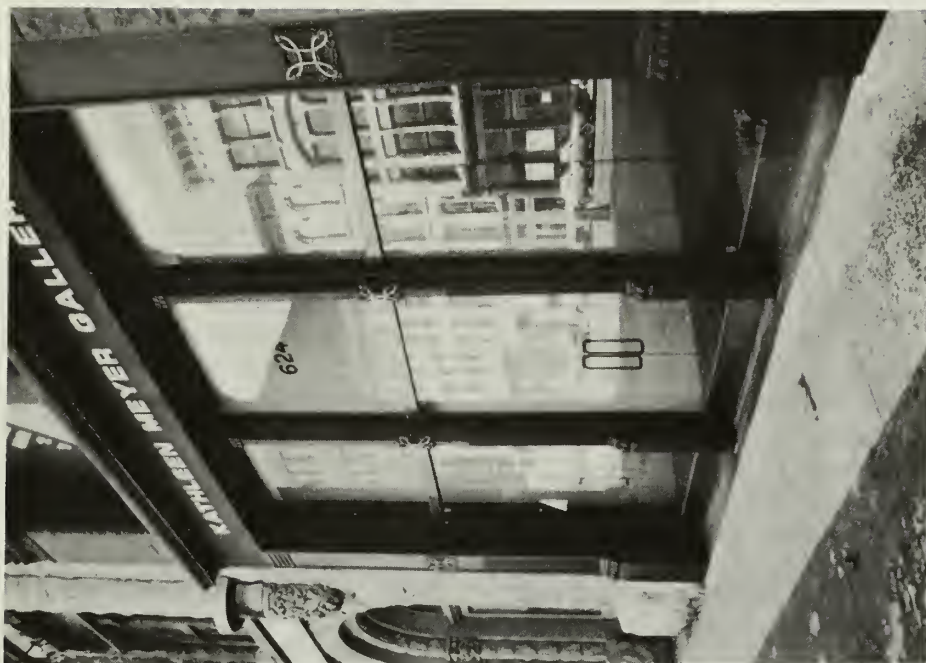
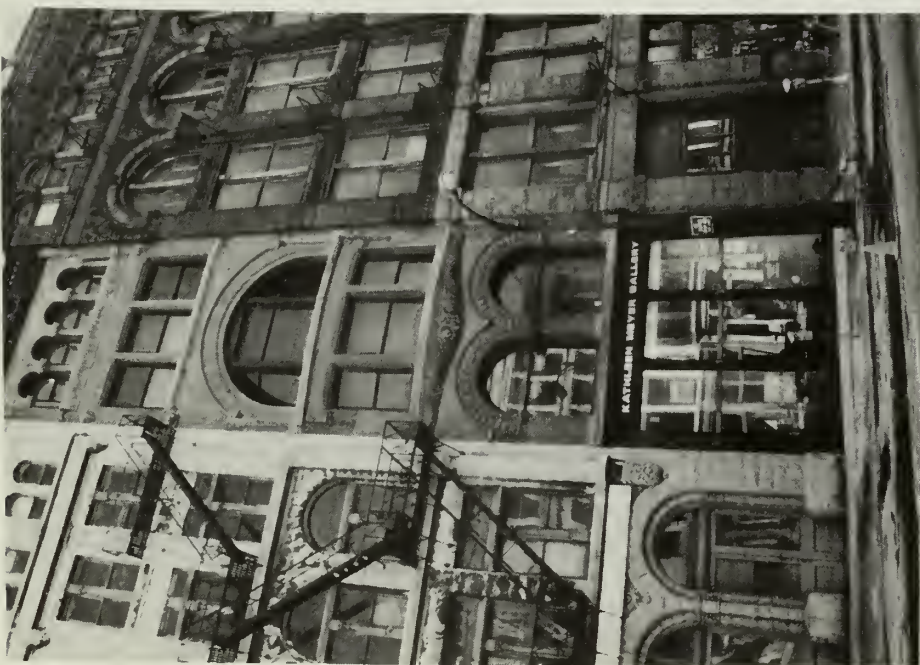
3 and 4. Overall and detail views, after installation of the compatible new storefront features. Note the 1930s-1940s features have been replaced, while the new design successfully retains the 3-bay division defined by the decorative cast-iron columns and cornice. The original cast-iron storefront elements have been painted dark brown as well as upper level window trim and cornice.

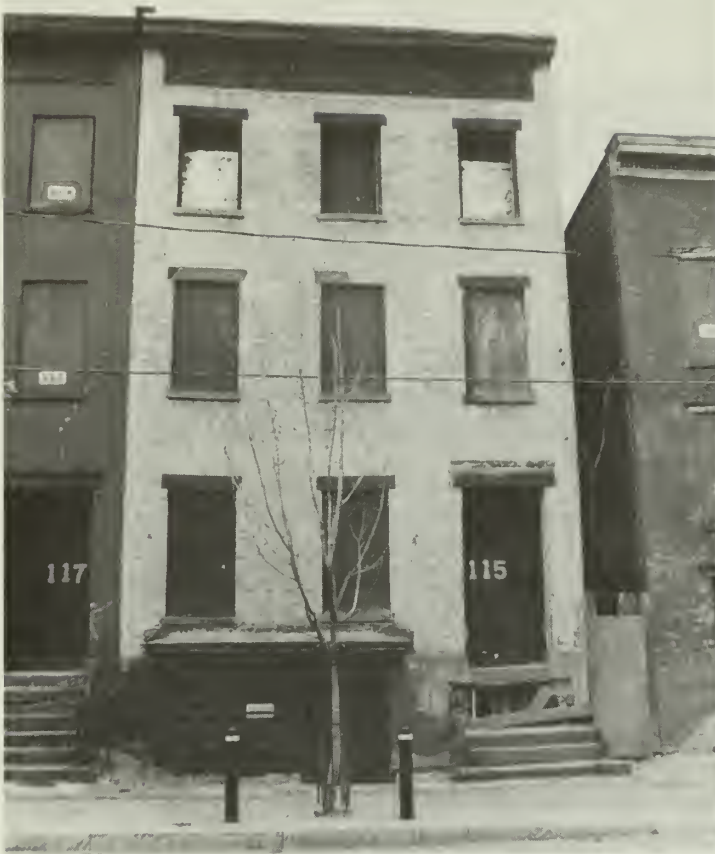
1. Although photographic documentation submitted with the Part 1 application showed some deterioration and loss on the primary elevation, NPS determined that the building exhibited sufficient "integrity" to qualify as a certified historic structure.
